The Peninsula's Community College

# **Municipal Separate Storm Sewer System Annual Report**

**Reporting Period: July 1, 2020 to June 30, 2021**

General Permit No. VAR040087

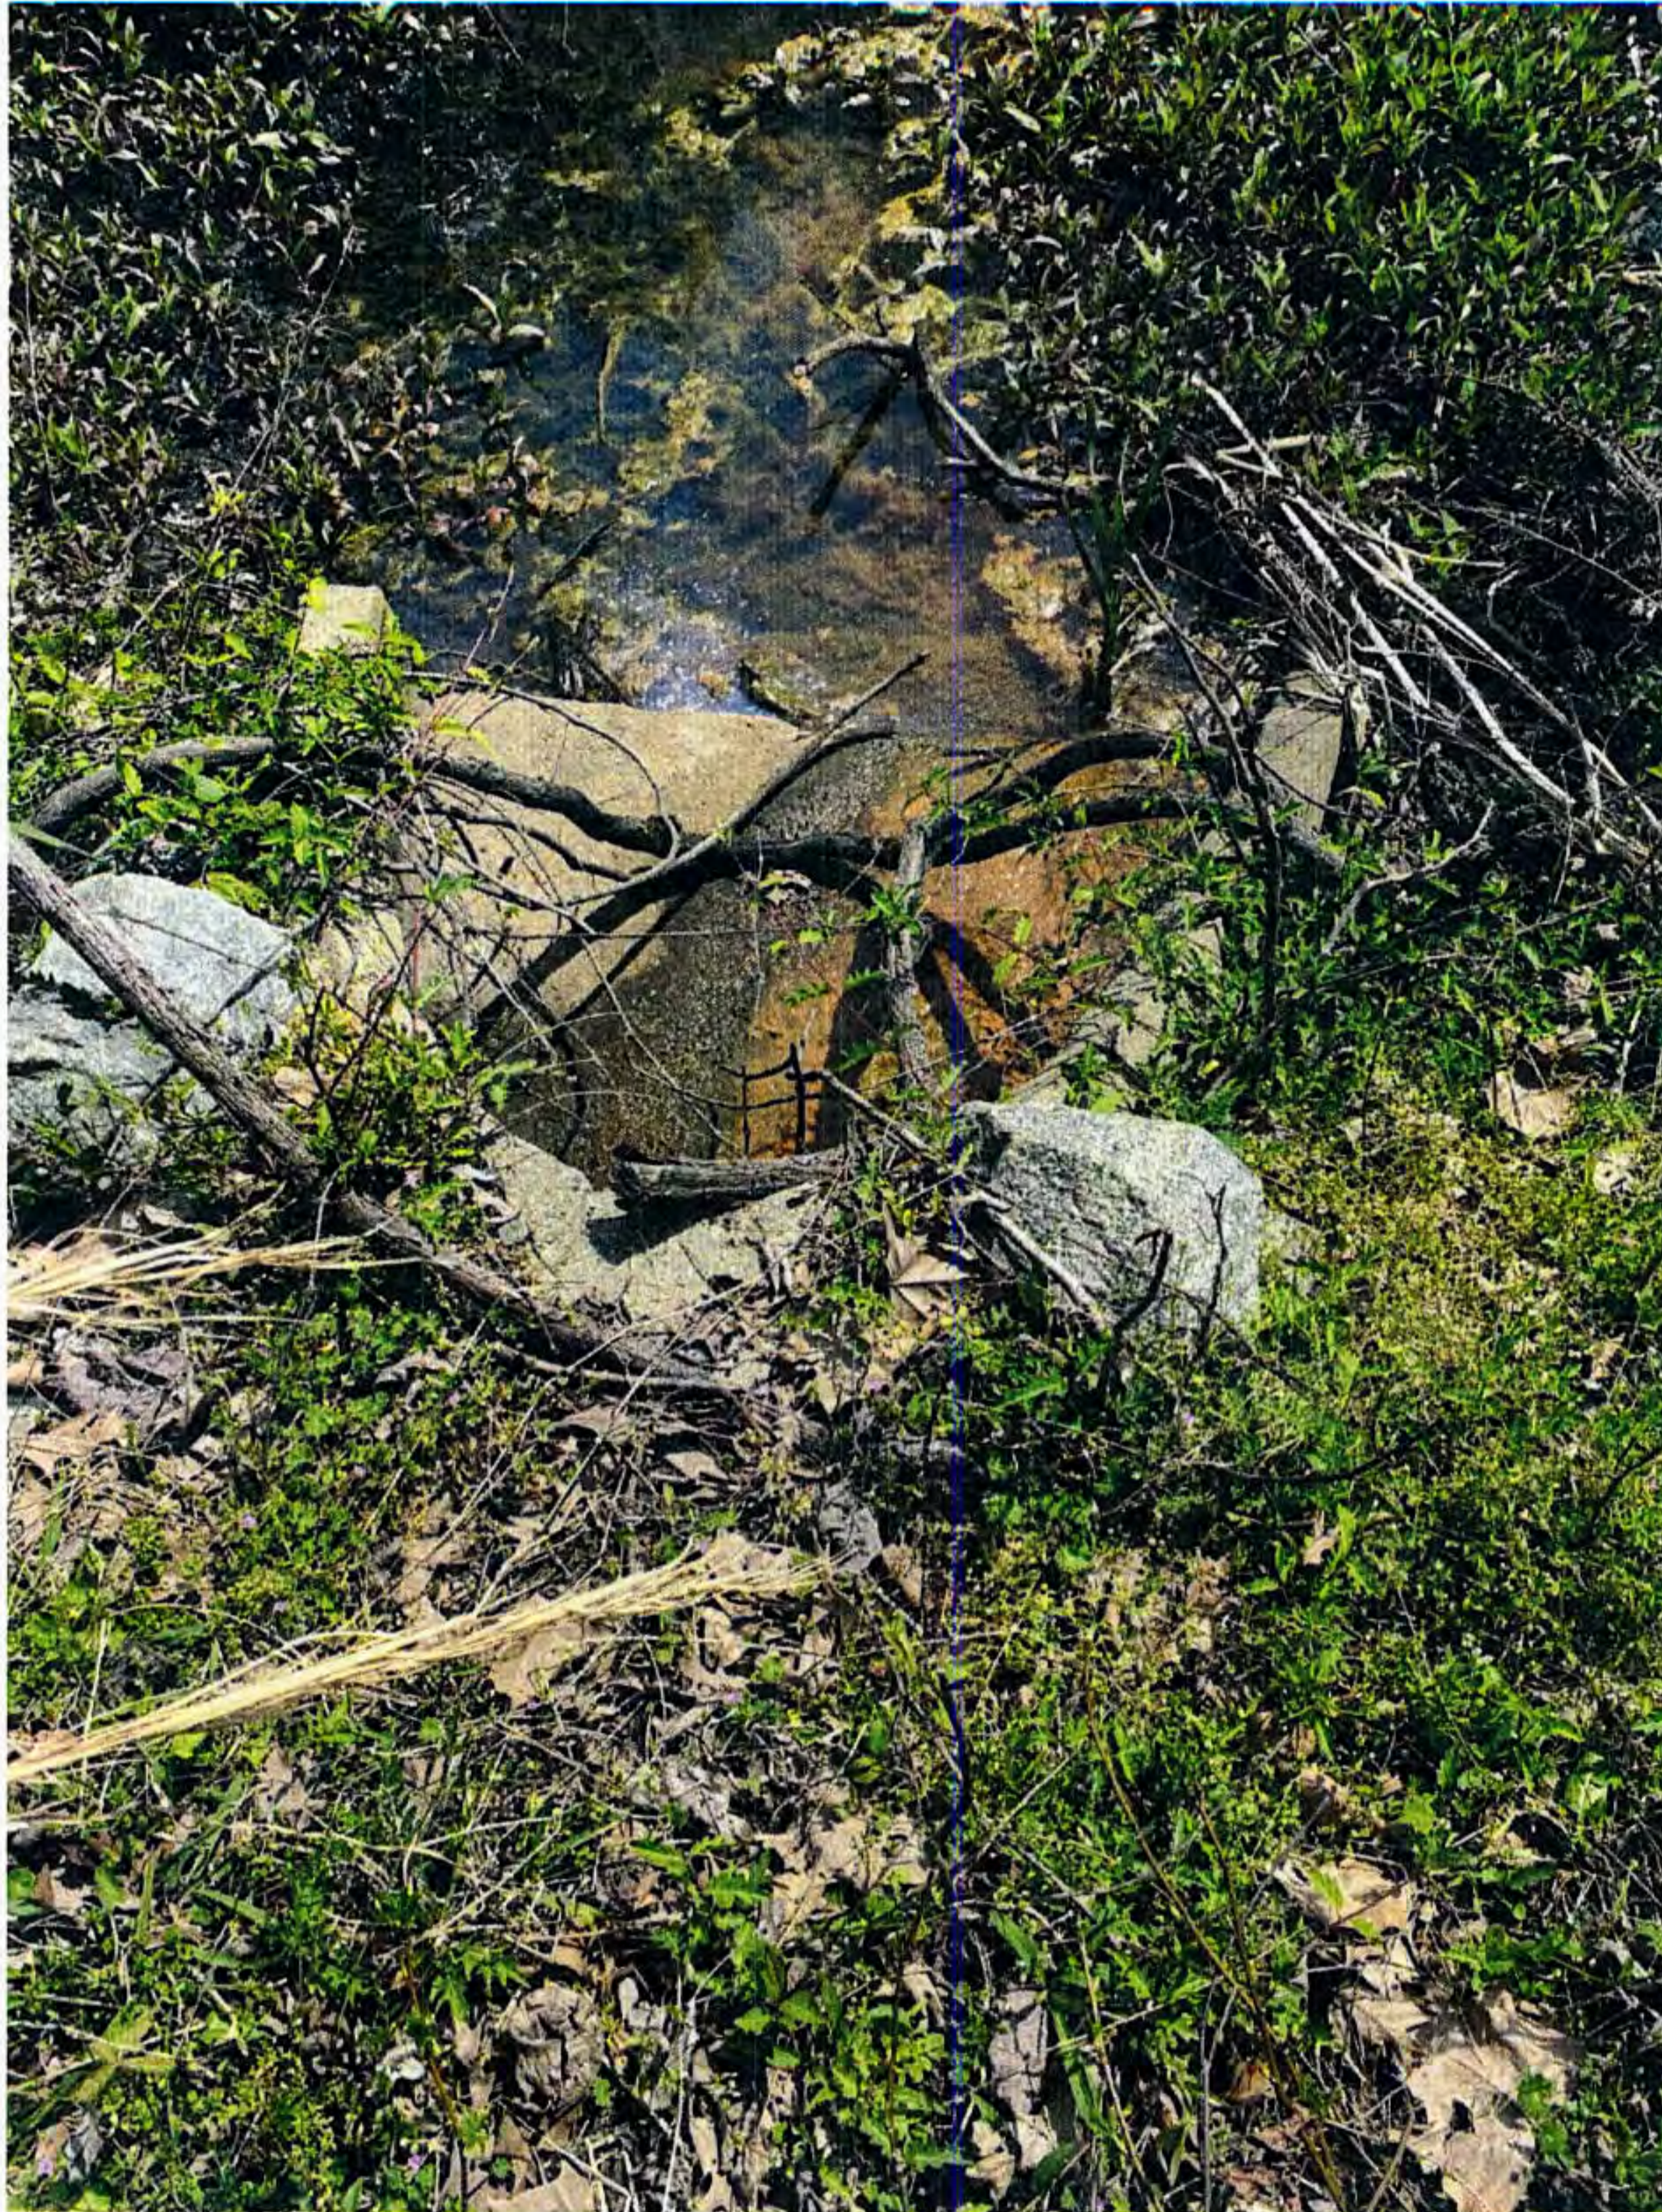
**Photo #OF-G-1.** In flat area of pipe end section – accumulated orange deposits/stains similar to pavement staining color near dumpster.

<b>Effectiveness Assessment for Addressing Illicit Discharges</b>	
Were all instances of identified illicit discharge listed in Appendix A closed?	
<p><i>Yes. One apparent illicit discharge was observed at OF-G near the Hampton III building. The illicit discharge was tracked to a leaky nearby dumpster. TNCC contacted the contractor, Waste Management, to address the issue. The drain cap was replaced and signage has been installed requesting the top be closed after use. Effectiveness of the remedy will be assessed with future outfall inspections.</i></p>

<b>Effectiveness of Program to Prevent Illicit Discharges from Campus Operations</b>	
Were there any illicit discharges from BMP 3C reporting that originated from campus operations of maintenance activities?	<input checked="" type="checkbox"/> Yes <input type="checkbox"/> No
Total number of illicit discharges originating from campus operations of maintenance activities:	1
Describe any potential changes to the <i>TNCC Staff Handbook for Good Housekeeping and Pollution Prevention</i> to prevent future occurrences, if applicable. <i>Refer to reporting for BMP 3C regarding the illicit discharge instance. No changes are needed as dumpster operations are addressed in the Handbook. The issue was related to a faulty drain plug.</i>

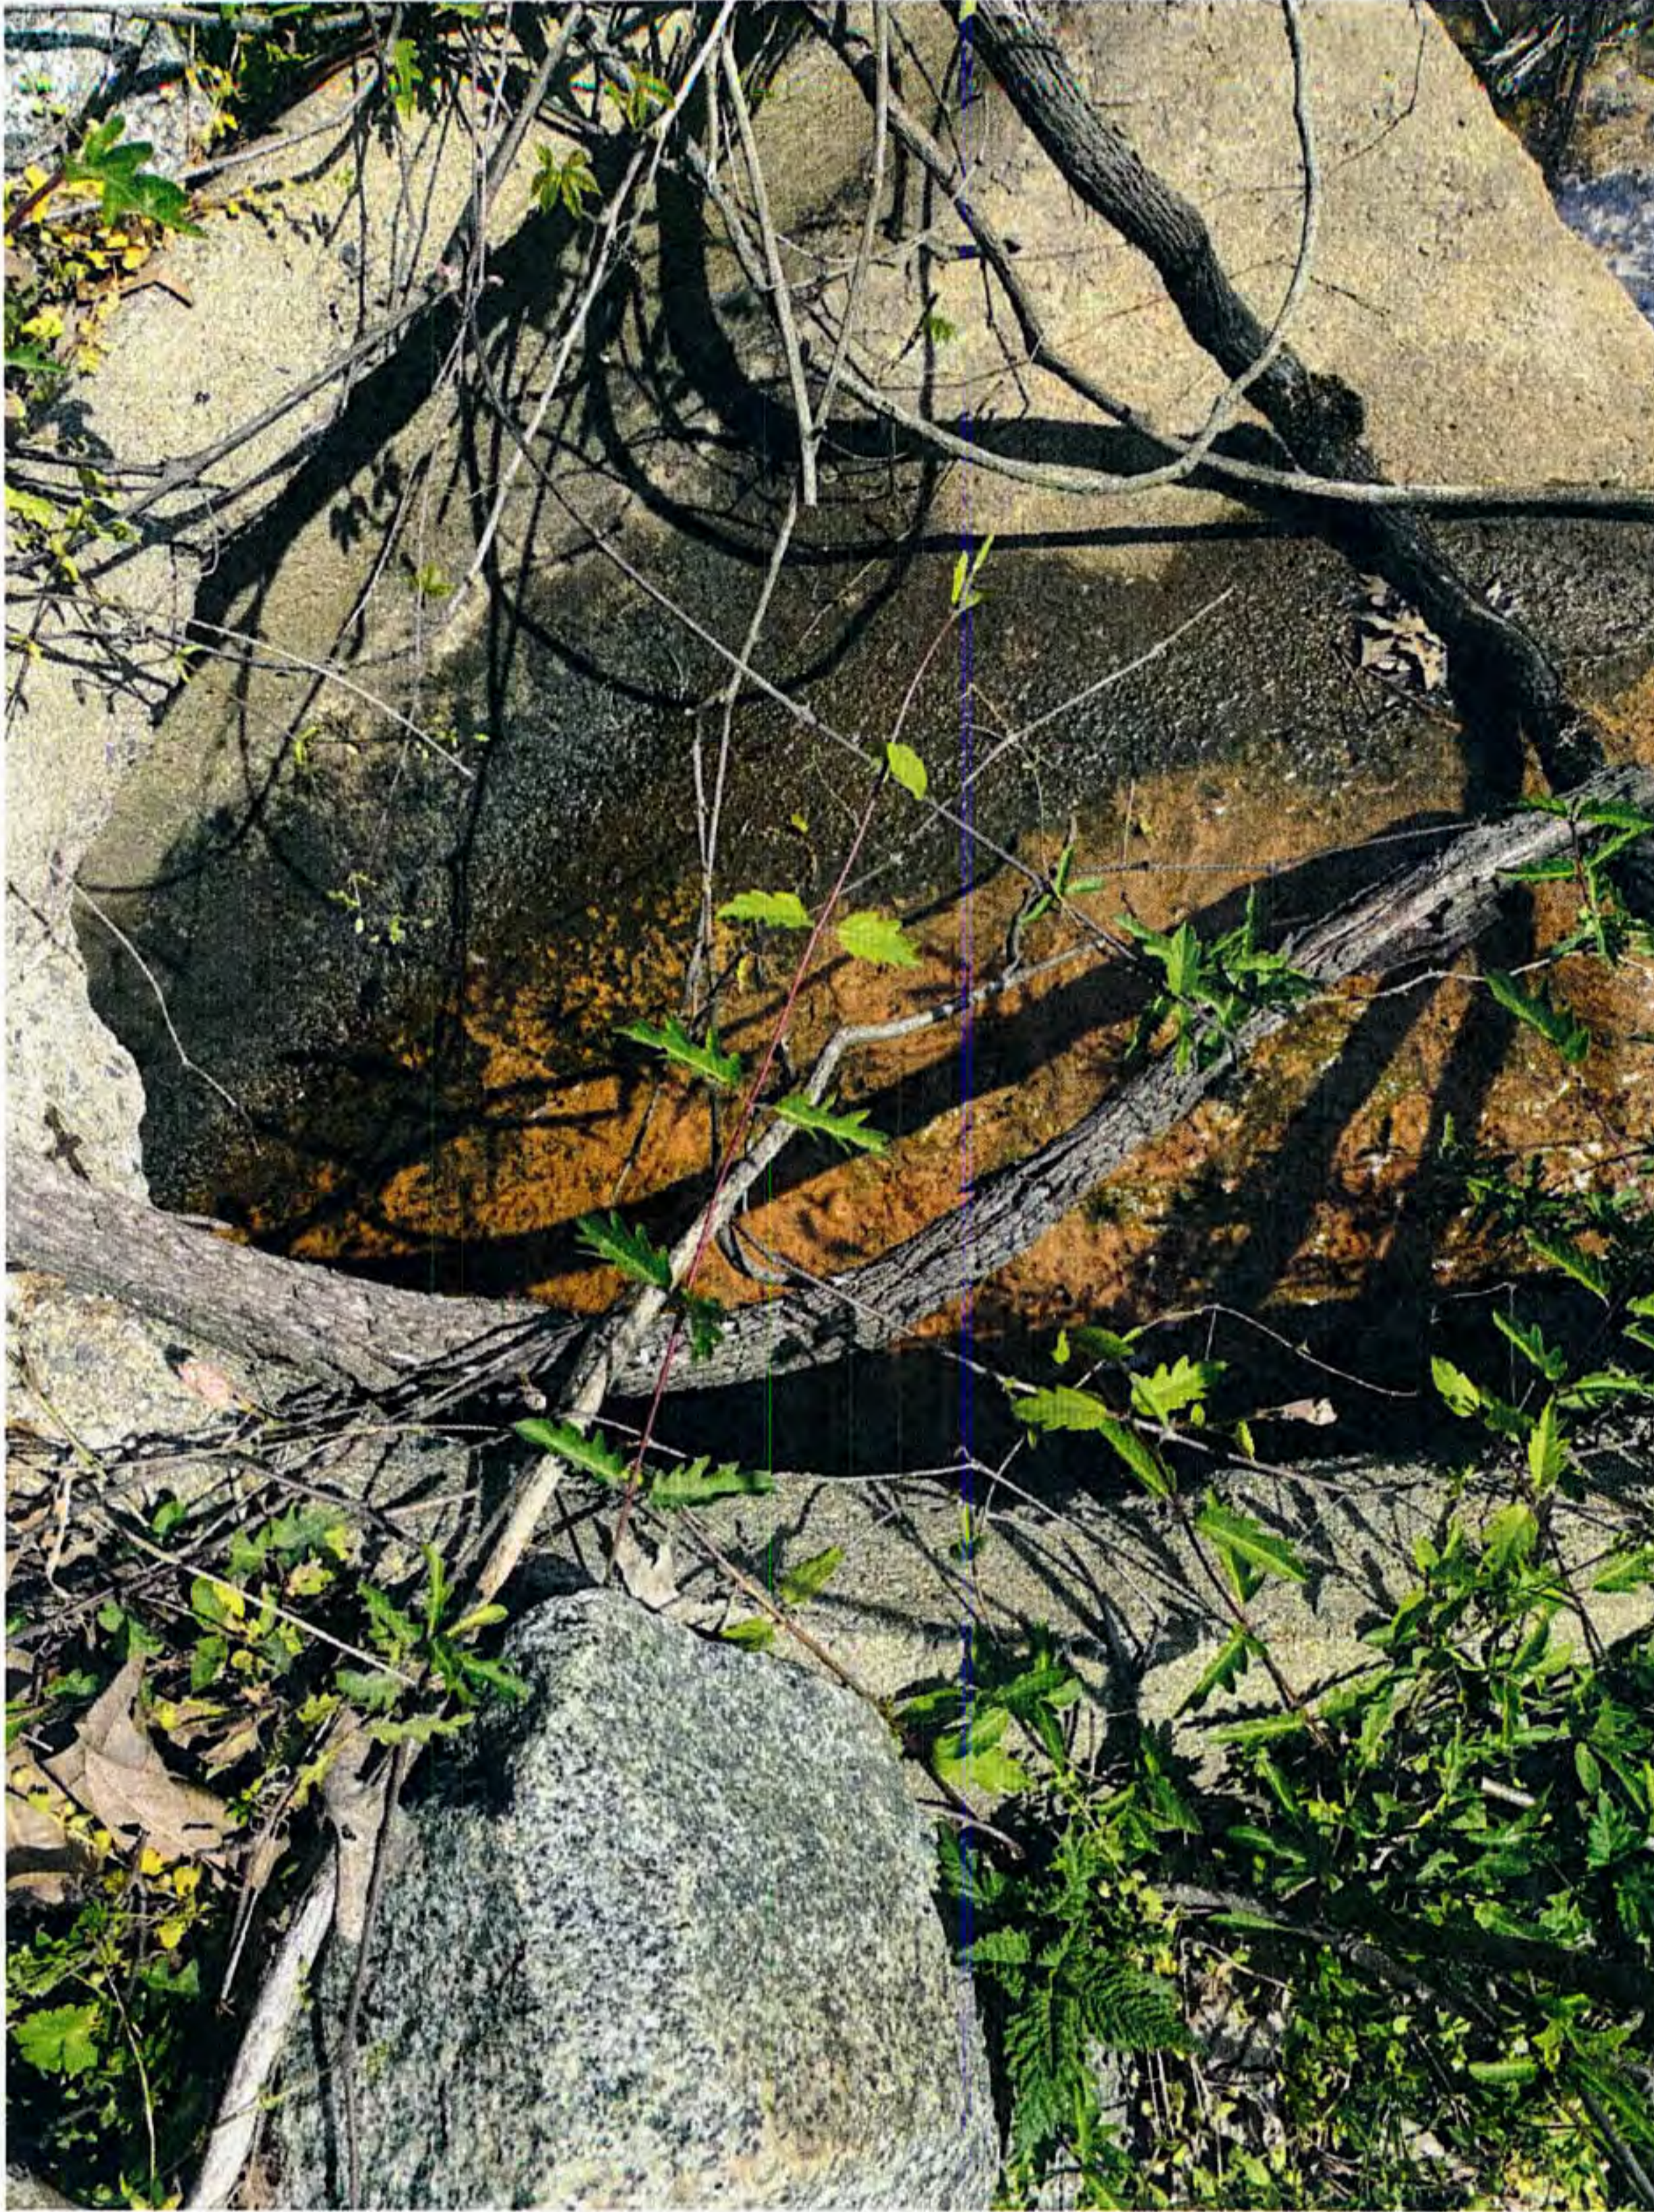
**Photo #OF-G-2.** In flat area of pipe end section – accumulated orange deposits/stains similar to pavement staining color near dumpster.

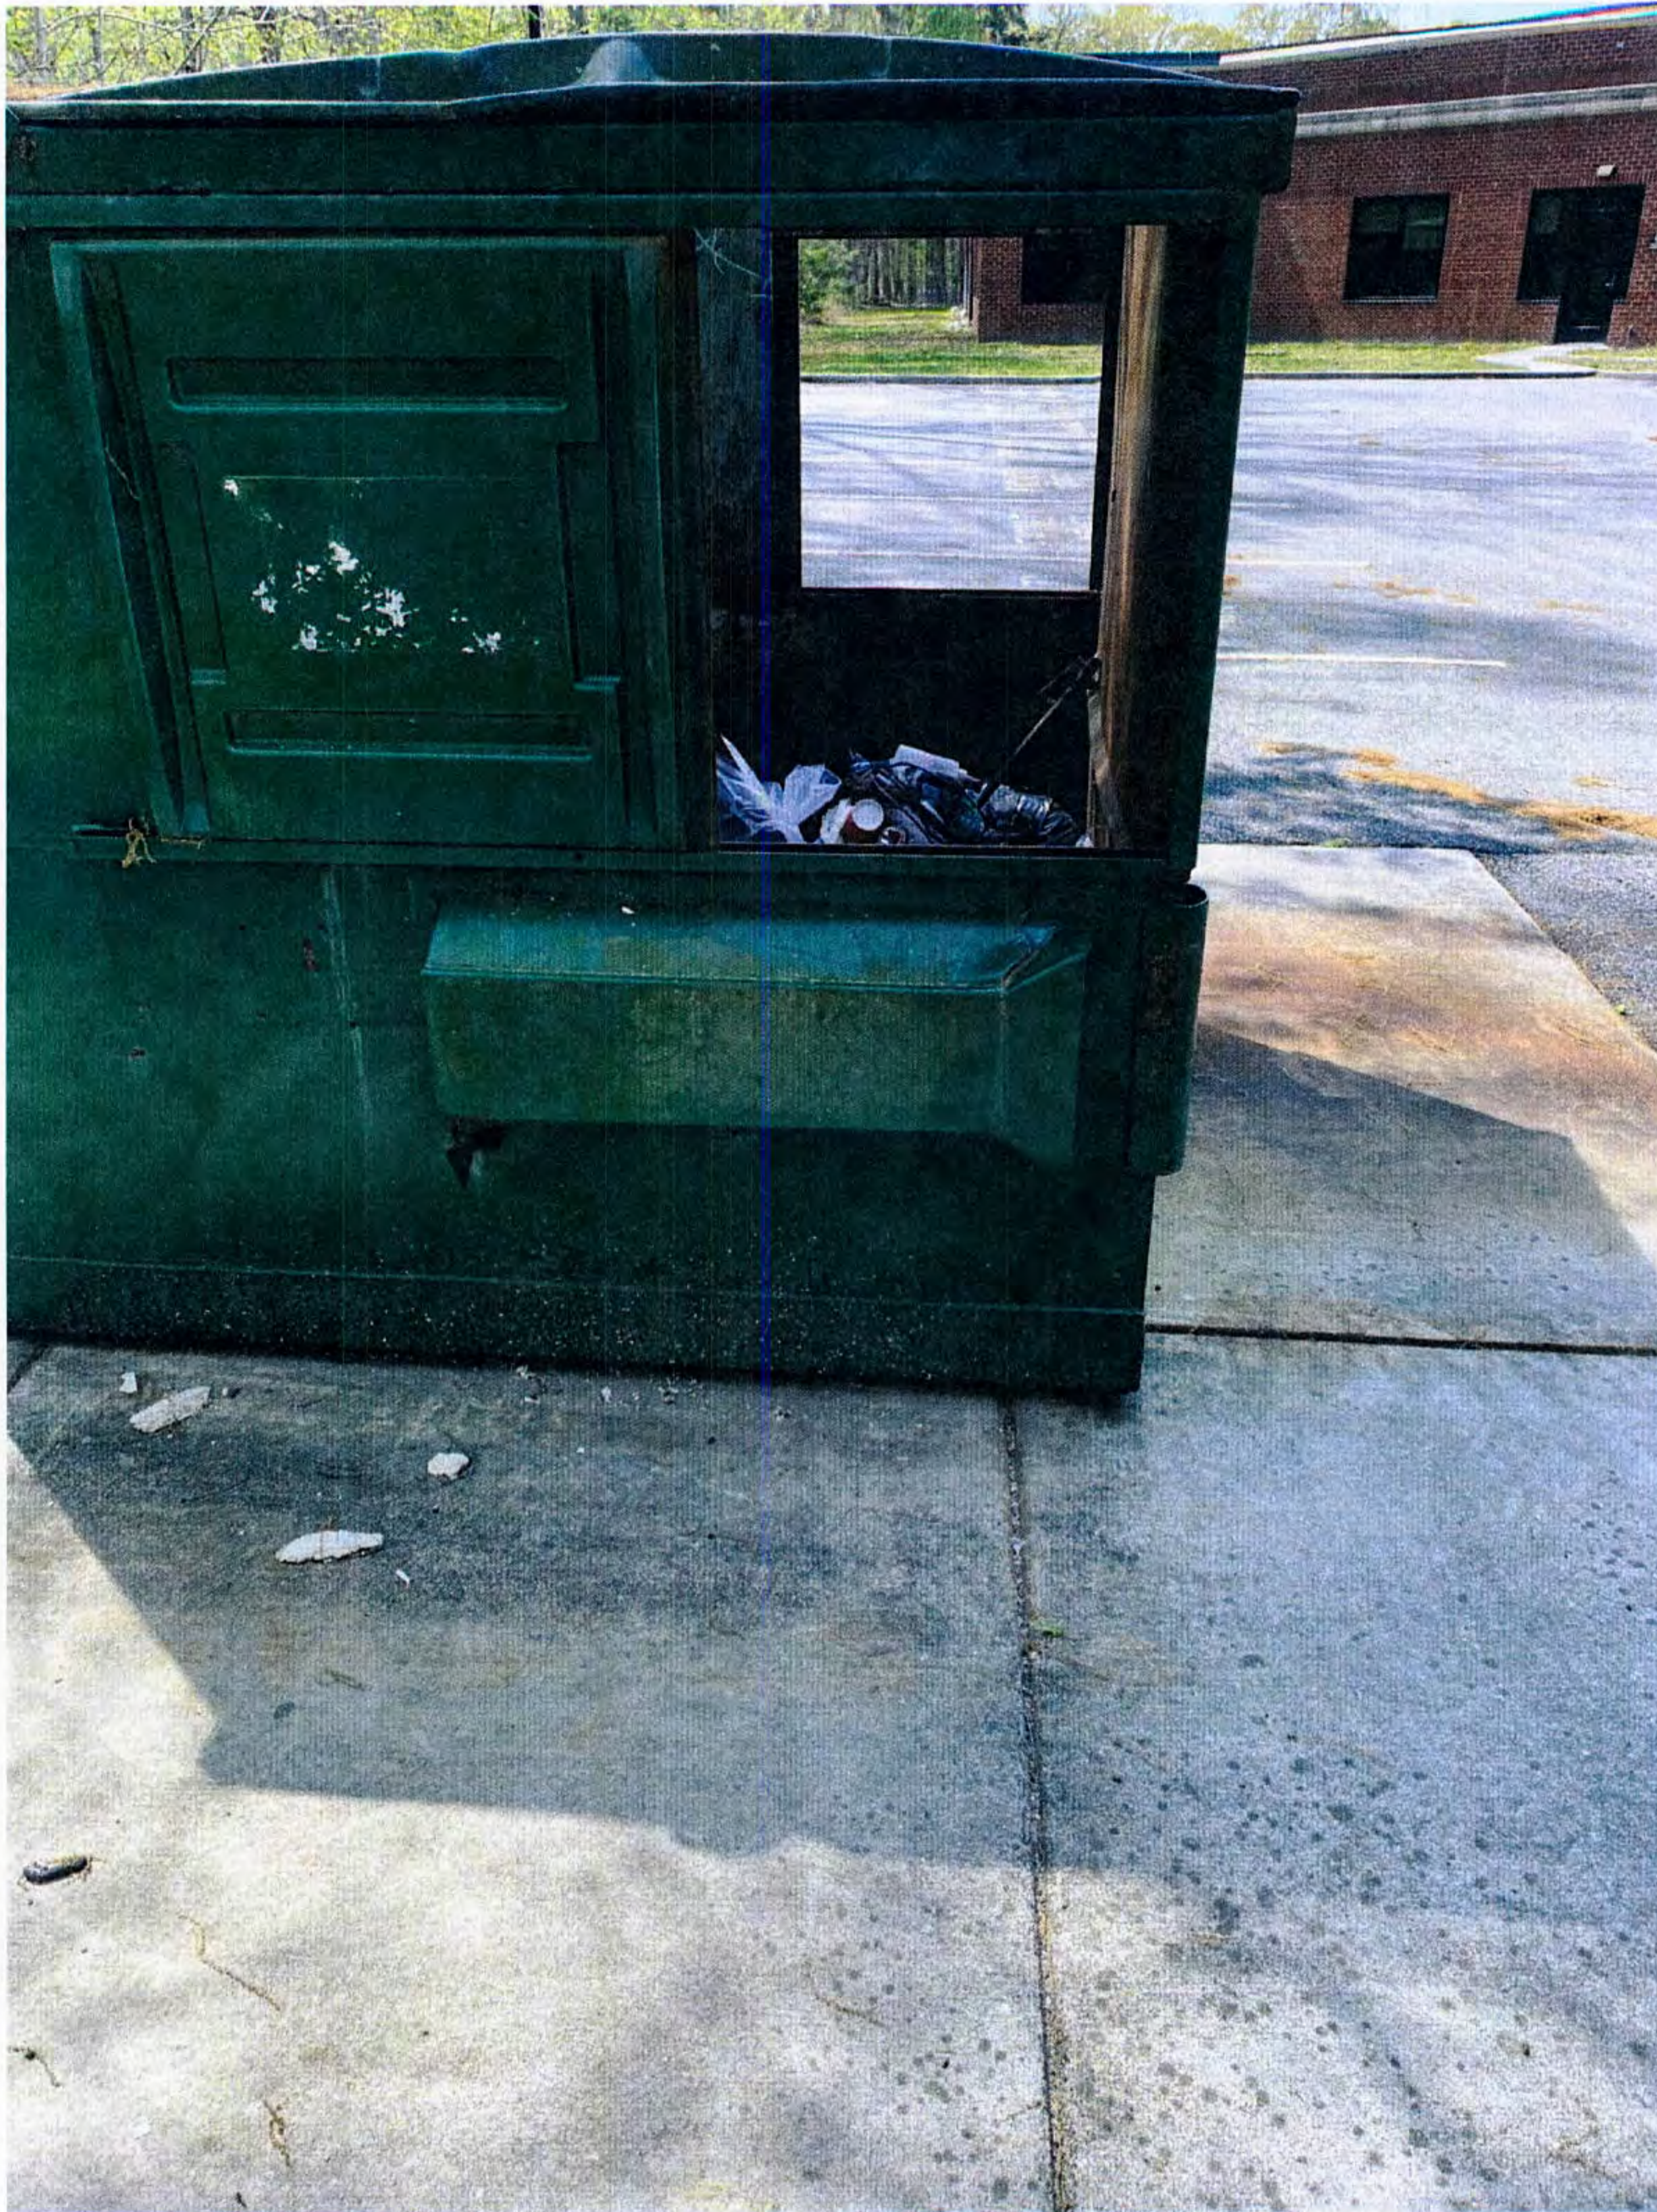
**Photo #OF-G-3.** Staining apparent on pavement all the way to receiving inlet (see also 2019-2020 report for this outfall). Staining indicates leak(s) in the bottom of dumpster. Dumpster also observed to be open, allowing for exposure of contents to stormwater.
